FLARM Firmware Release Notes

Version 7.24

Platforms	All PowerFLARM, Atom and Classic FLARM-based devices
Build	ab6c756fe
Expiration	Not operational after 28 February 2026

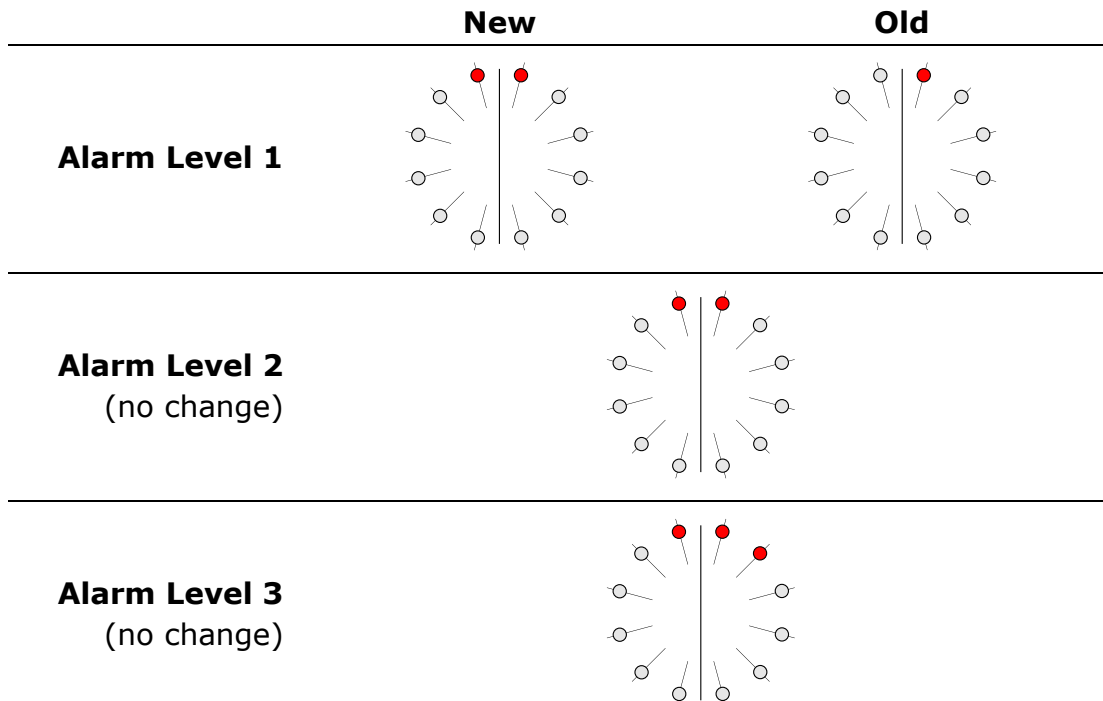
Note: Head-on ($\pm 15^\circ$) traffic and collision warnings on Classic FLARM F6–F9 are indicated as shown in the graphic below (the traffic in this example comes from $+5^\circ$ relative bearing).
