<h1>FLARM FIRMWARE RELEASE NOTES</h1>	Date: 2022-06-06 Version: 1.1 Page: 1 of 42
FLARM Technology AG Industriestrasse 49 CH-6300 Zug		Document Number: FTD-037

FLARM Firmware Release Notes

Published 28 April 2025

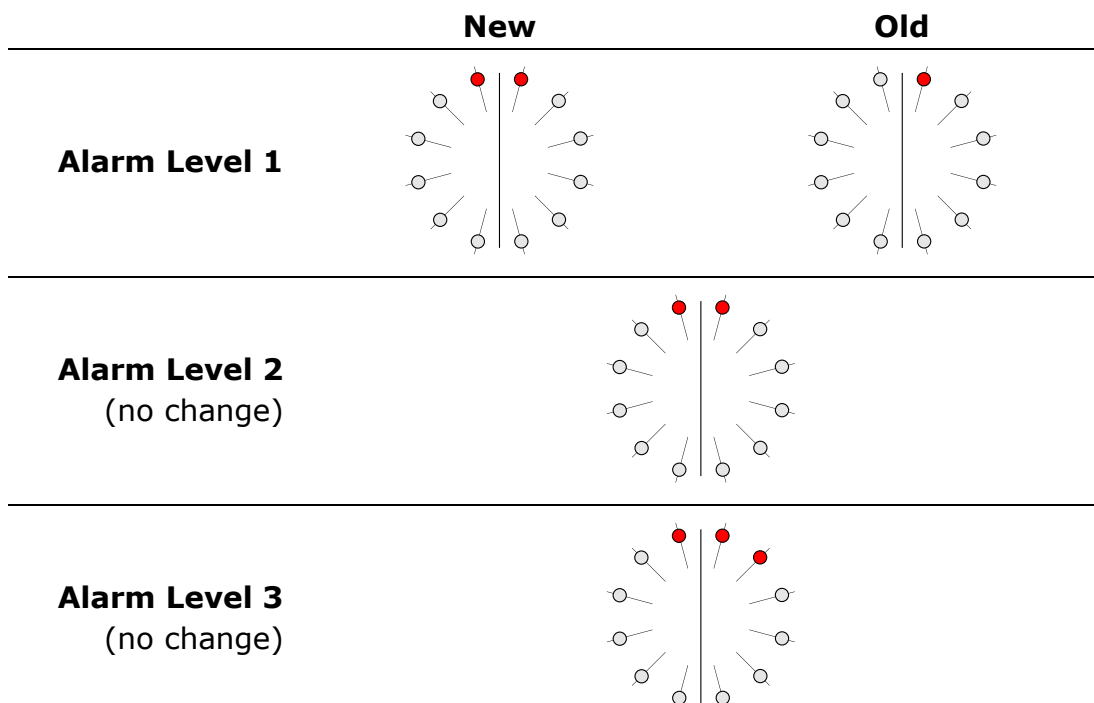
Note: Head-on ($\pm 15^\circ$) traffic and collision warnings on Classic FLARM F6–F9 are indicated as shown in the graphic below (the traffic in this example comes from $+5^\circ$ relative bearing).
