| | <h1>FLARM FIRMWARE<br/>RELEASE NOTES</h1> | Date: 2022-06-06<br>Version: 1.1<br>Page: 1 of 44 |

# FLARM Firmware Release Notes

# Version 7.42

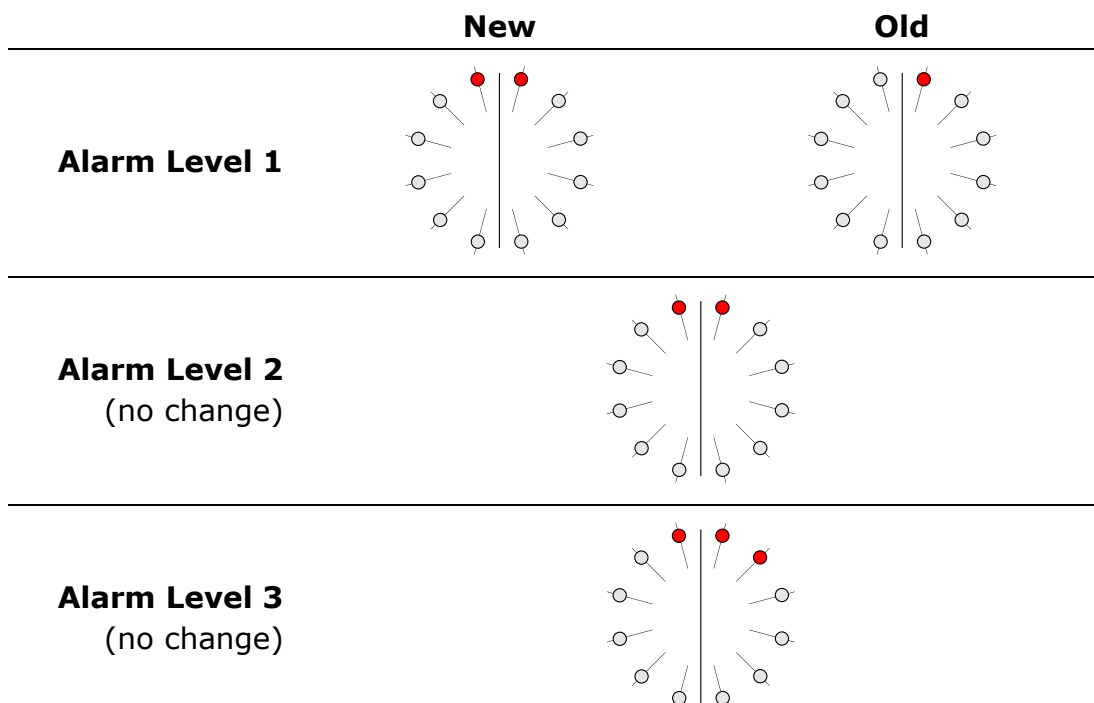
**Note:** Head-on ( $\pm 15^\circ$ ) traffic and collision warnings on Classic FLARM F6–F9 are indicated as shown in the graphic below (the traffic in this example comes from  $+5^\circ$  relative bearing).
