<b>FLARM</b> TECHNOLOGY	<b>FLARM FIRMWARE RELEASE NOTES</b>	Date: 2022-06-06 Version: 1.1 Page: 1 of 45
FLARM Technology AG Industriestrasse 49 CH-6300 Zug		Document Number: <b>FTD-037</b>

# FLARM Firmware Release Notes

Published 6 February 2026

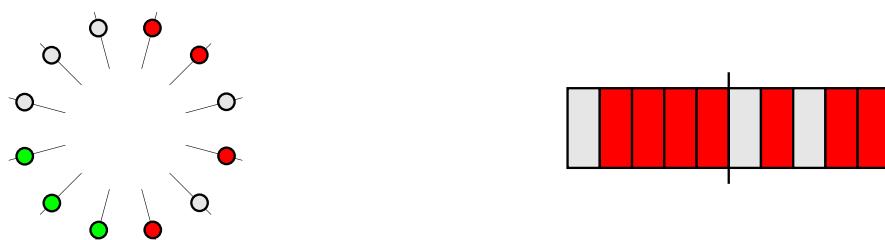
- Classic: Improved `$GPRMC` message handling to ensure only valid sentences are forwarded.
- On Classic FLARM, the firmware version is indicated as shown in the graphics below:

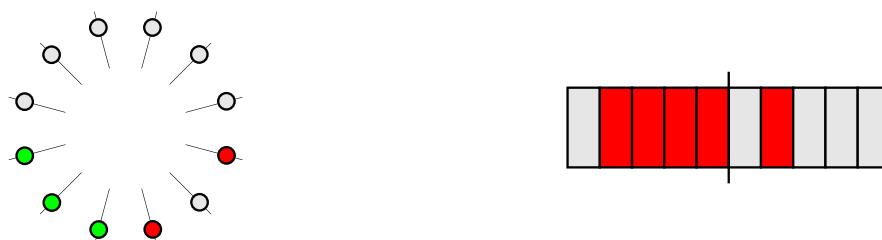
**Note:** On Classic FLARM, the firmware version is indicated as shown in the graphics below:
