<h1>FLARM FIRMWARE RELEASE NOTES</h1>	Date: 2022-06-06 Version: 1.1 Page: 1 of 46
FLARM Technology AG Industriestrasse 49 CH-6300 Zug		Document Number: <b>FTD-037</b>

# FLARM Firmware Release Notes

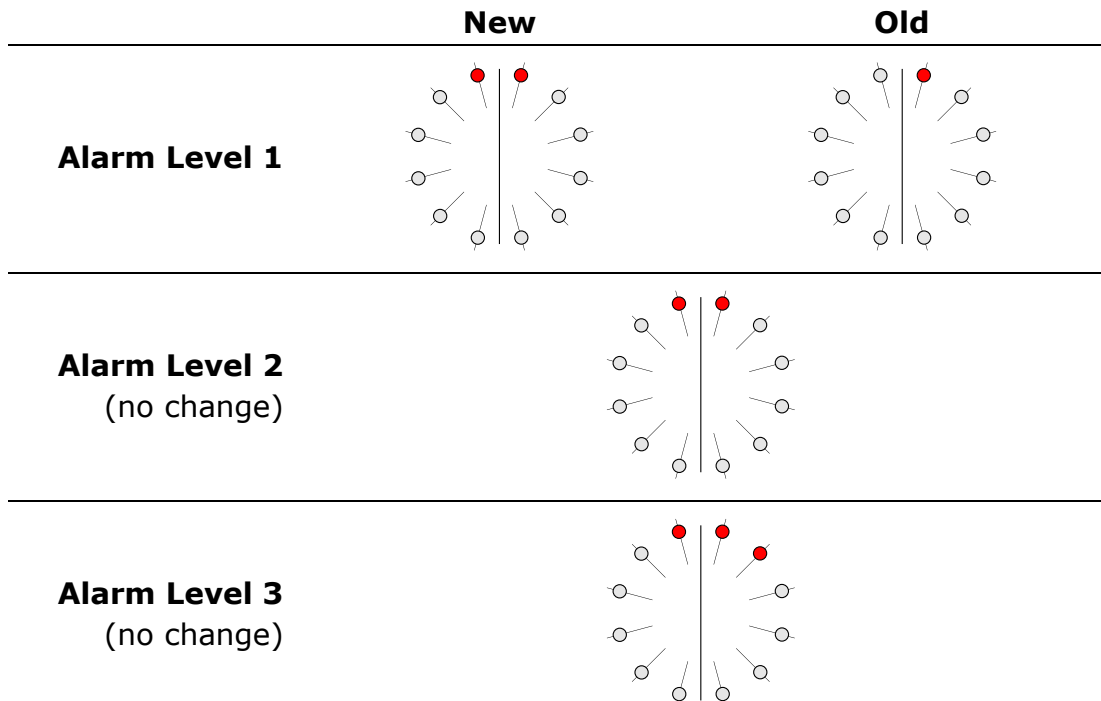
**Note:** Head-on ( $\pm 15^\circ$ ) traffic and collision warnings on Classic FLARM F6–F9 are indicated as shown in the graphic below (the traffic in this example comes from  $+5^\circ$  relative bearing).
